INSPECTION OF AIRCRAFTS' WHEELS, THEIR MATERIALS AND APPLICATIONS – A REVIEW

Şahin Karakaya^{1*}, Tahir Altinbalik²

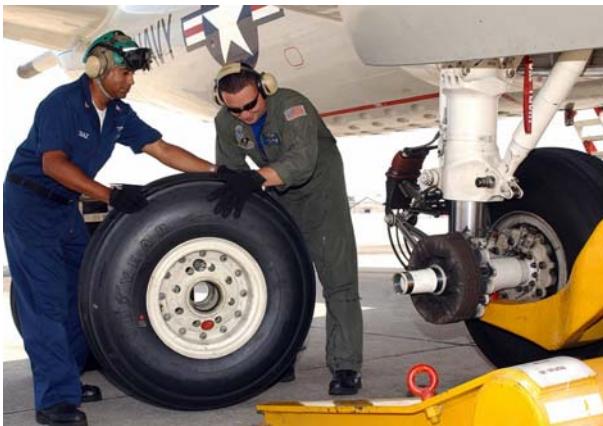
Fig. 2. Wheel on a Lockheed P-3 Orion aircraft

Although the landing gear and the wheels that are part of it were initially very weak in the aviation industry, today aircrafts have a very strong design that can absorb forces (Fig. 2).

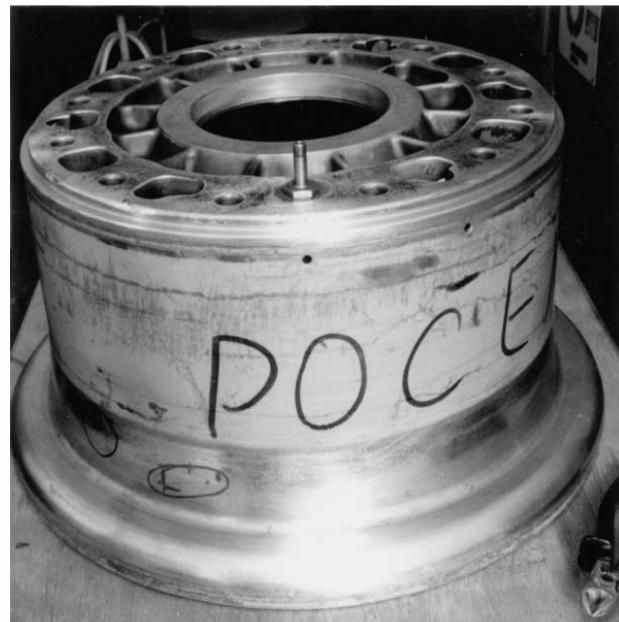
Fig. 3. The crack in the rim of an aircraft wheel

B. Kosec, Kovacic and L. Kosec, studied on fatigue cracking on wheels of aircraft [7]. In case of malfunctions in aircraft parts, fault detections are usually revealed by non-destructive testing methods and examination is provided accordingly. These faults can be complex in some cases. Fractographic and metallographic methods are definitely important for the detailed description and interpretation of fault. This article concerns a crack in an aircraft wheel rim. The wheel is made of 2014-T6 aluminum alloy. The crack was found during a regular inspection by the non-destructive testing maintenance unit of the Slovenian Airline Adria Airways. The crack in the examined rim is a typical fatigue crack. Rims are subjected to strong mechanical stress and atmospheric effects during landing and take-off. The crack in the rim examined in this article is a fatigue crack. There are many pits on the rim surface and the crack spreads over them. Therefore, it is concluded that the pits act as stress concentrators on the rim surface and one of them eventually initiates the fatigue crack.
